Kent's Highways service

to create awareness and gain support for improvement
and better maintenance services for pavements,
lampposts and signage in Royal Tunbridge Wells

Case 2 - Mount Pleasant and Crescent Road - Streetlights

Date of survey:
13 March 2007

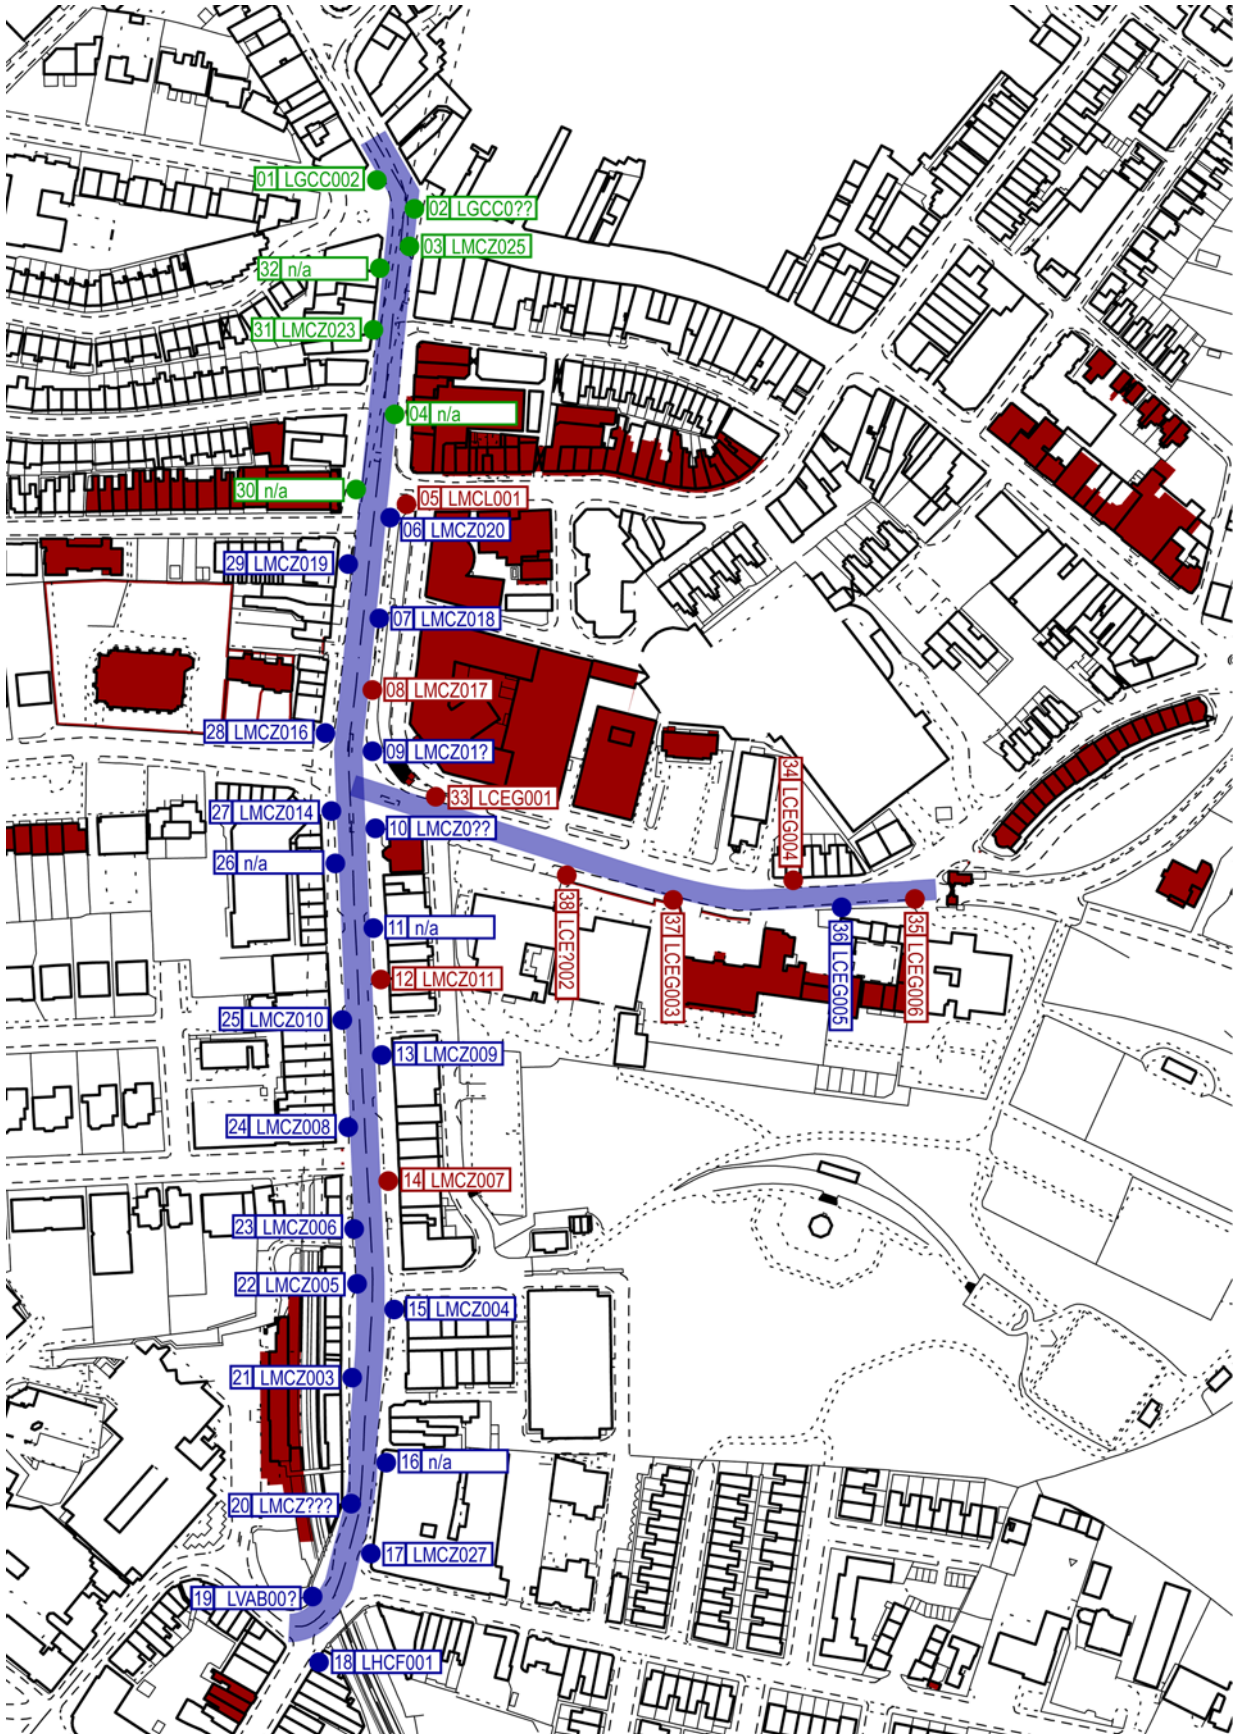
On 1 April 2005 the County Council became responsible for
delivering Kent's highways service creating three divisional offices
and maintaining a central Call centre for all enquiries.

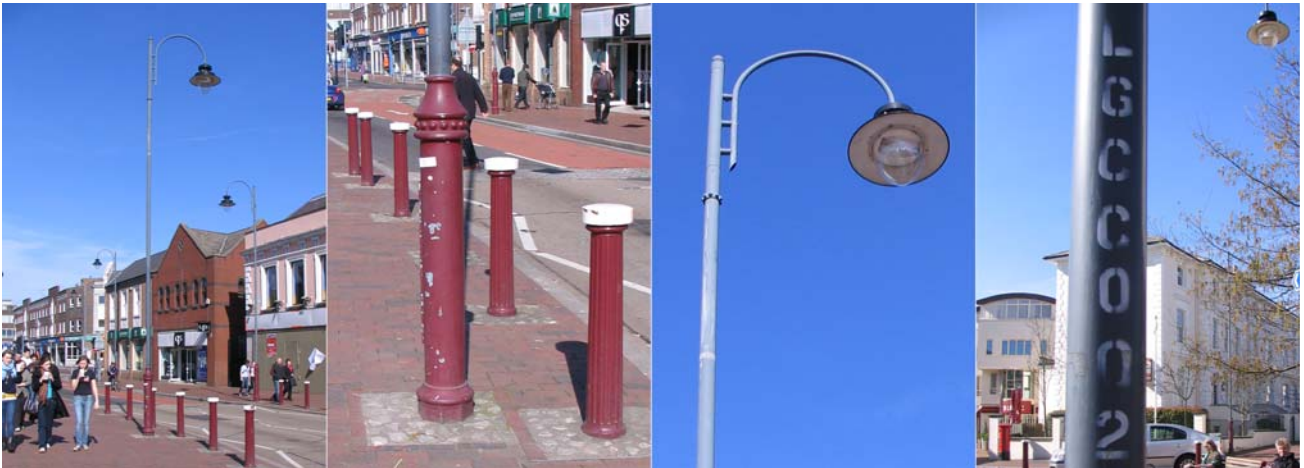
1 / LGCC002
Five Ways

STYLE: Replica

BASE: Replica

TOP: Replica

1) lamppost could replace bollard to avoid clutter

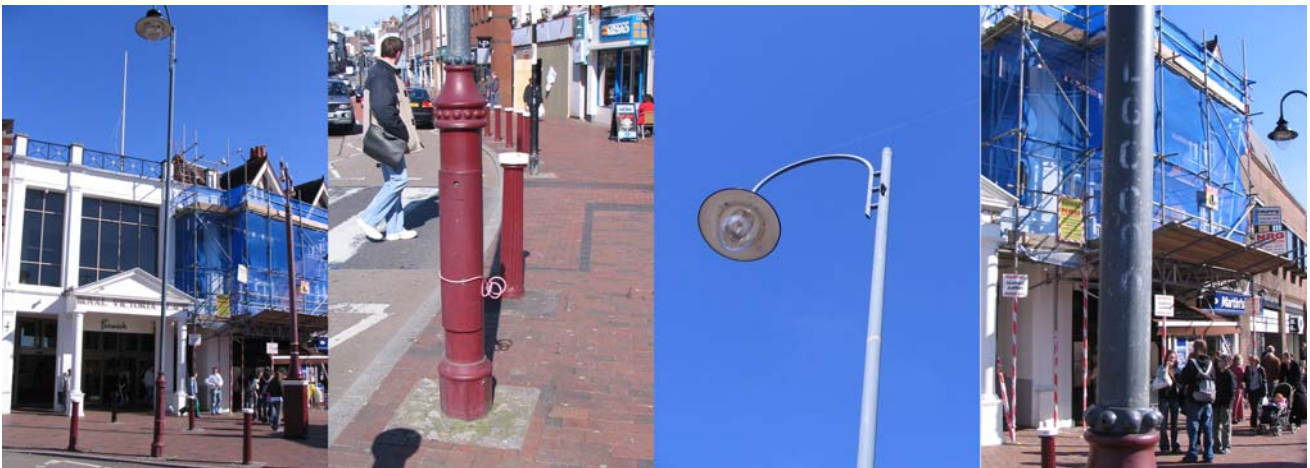
2 / LGCC0??
Five Ways

1) identification faded
2) electricity access door stringed

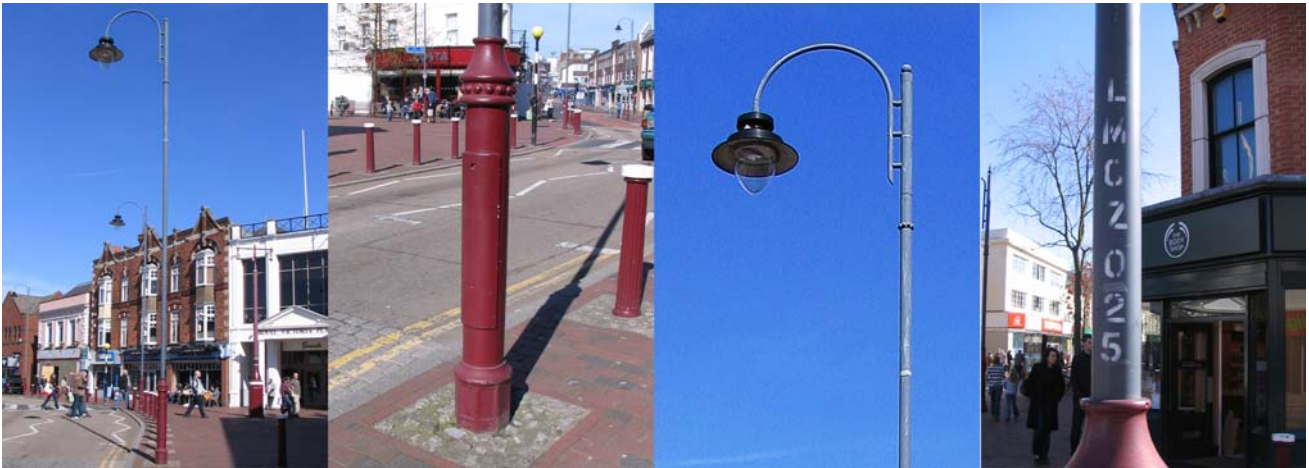
3 / LMCZ025
Five Ways

REMARKS: in contrast to 1/ LGCC002 lamppost is used as bollard

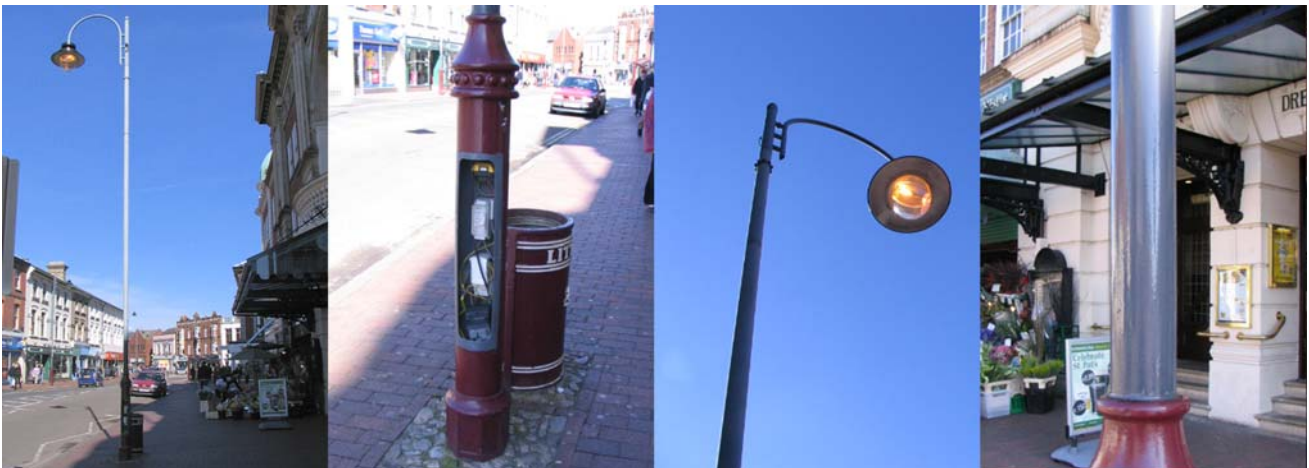
4 / (Opera House)
Mt. Pleasant

- 1) identification overpainted
- 2) light on during day
- 3) health hazard due to exposed live wires

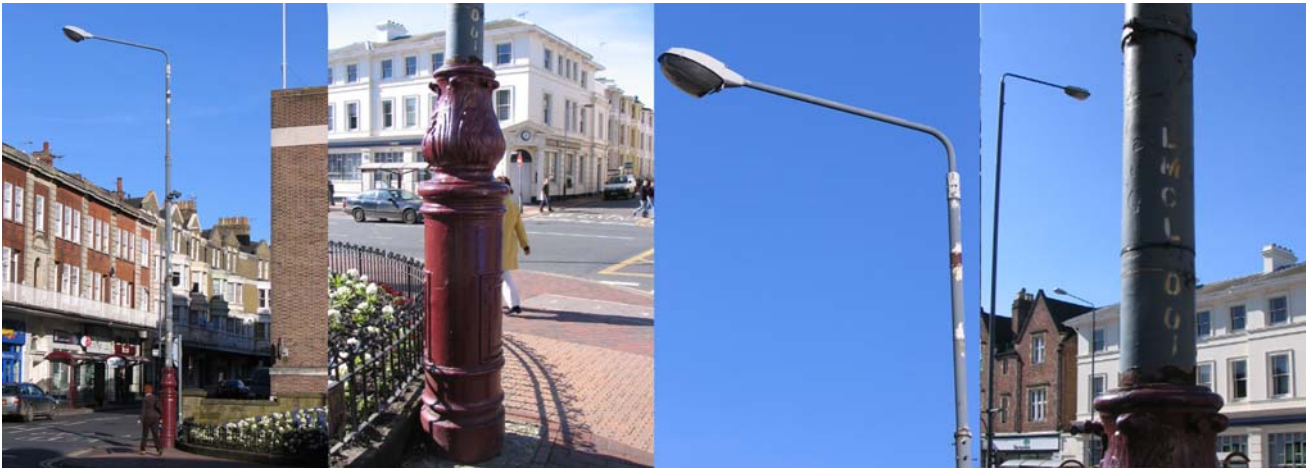
5 / LMCL001
Mt. Pleasant

STYLE: Victorian

BASE: original

TOP: modern, inappropriate for area

- 1) paint (grey) flaking on column
- 2) corrosion
- 3) lamp soiled inside

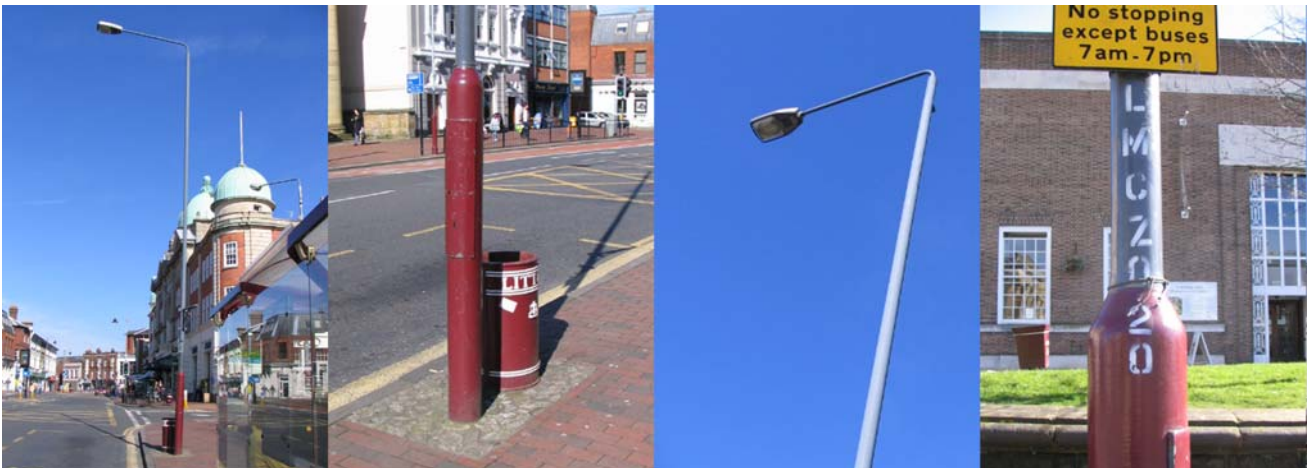
6 / LMCZ020
Mt. Pleasant

STYLE: 'Motorway'

BASE: modern, inappropriate for area

TOP: modern, inappropriate for area

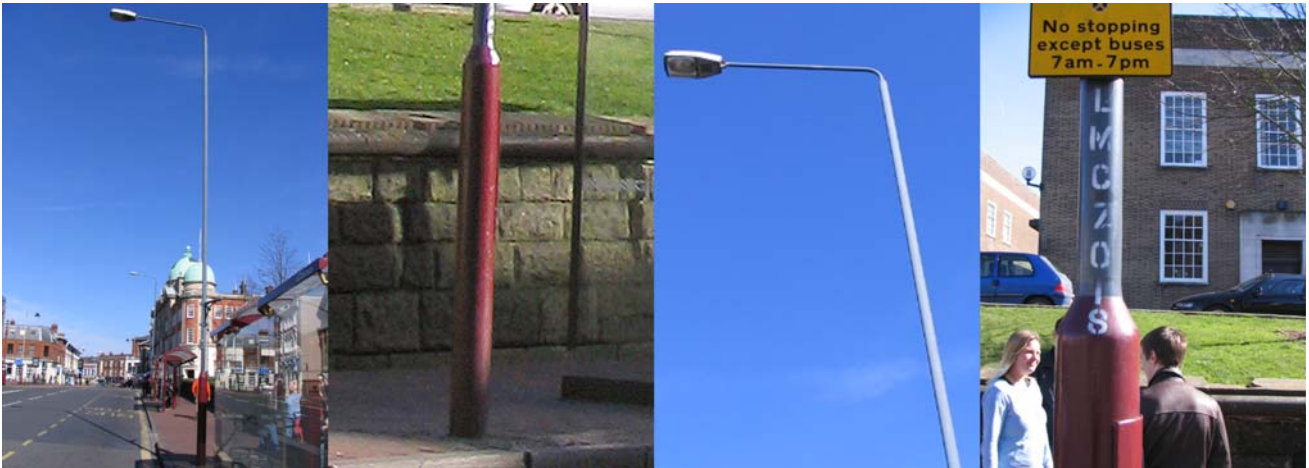
7 / LMCZ018
Mt. Pleasant

STYLE: 'Motorway'

BASE: modern, inappropriate for area

TOP: modern, inappropriate for area

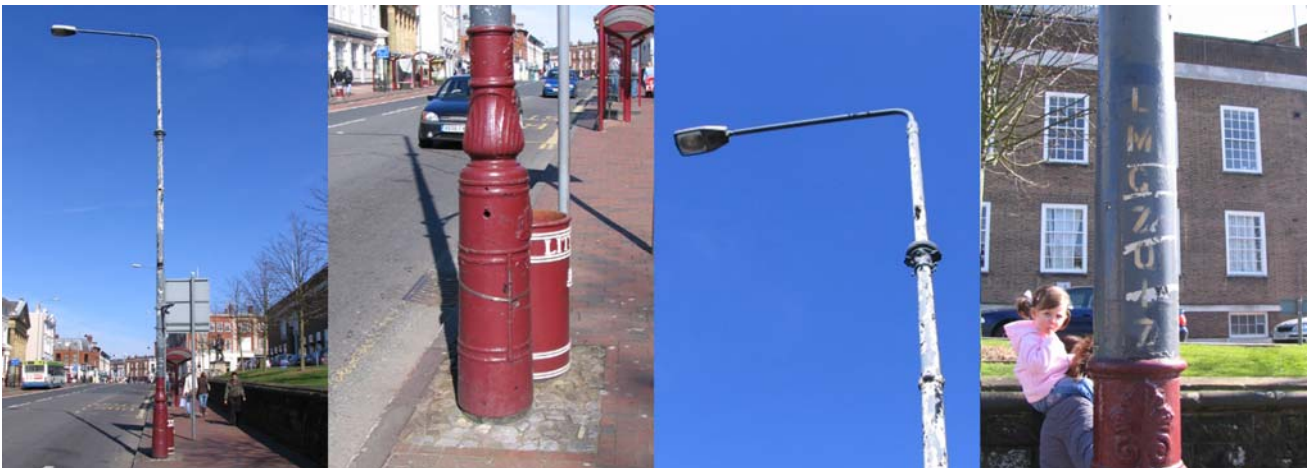
8 / LMCZ017
Mt. Pleasant

BASE: original, column original up to bracket

TOP: modern, inappropriate bracket for area

- 1) paint flaking on top column
- 2) corrosion
- 3) electricity access door strapped

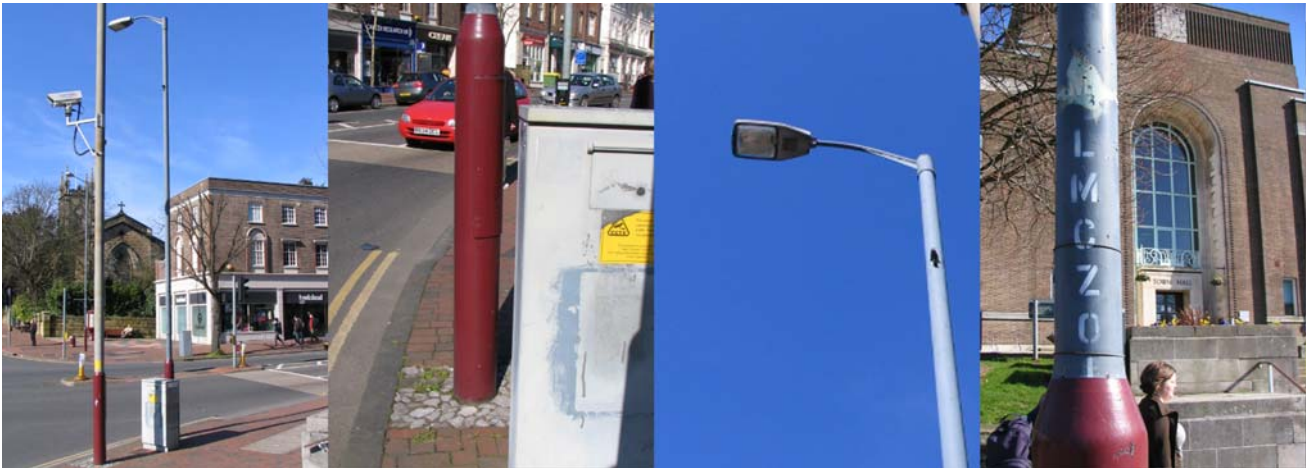
9 / LMCZ01?
Mt. Pleasant

BASE: modern, inappropriate for area

TOP: modern, inappropriate for area, cast, short bracket

- 1) identification partially overpainted
- 2) clutter in conjunction with the CCTV pole and feeder box

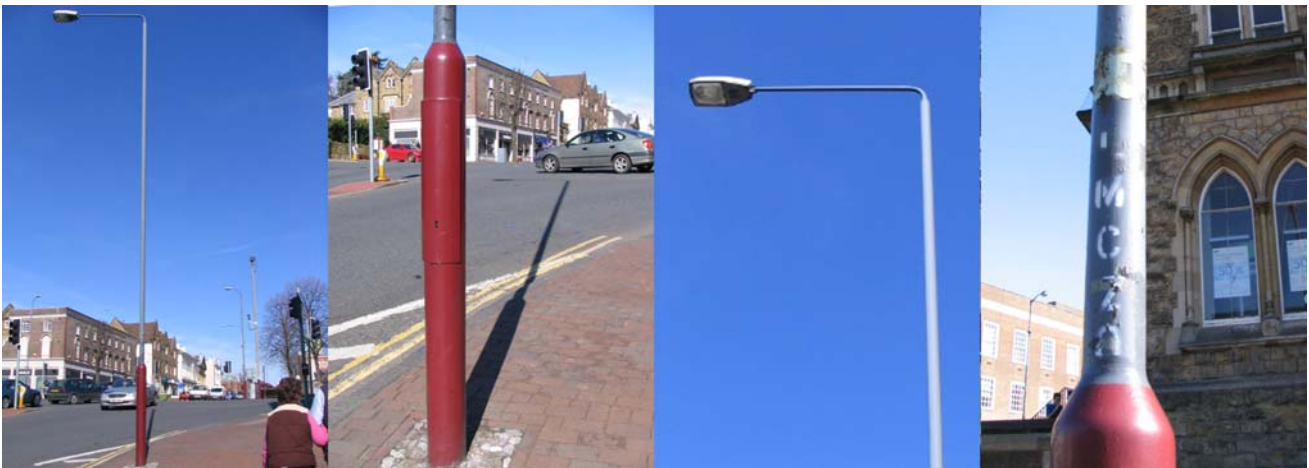
10 / LMCZ0??
Mt. Pleasant

BASE: modern, inappropriate for area

TOP: modern, inappropriate for area

- 1) identification partially overpainted

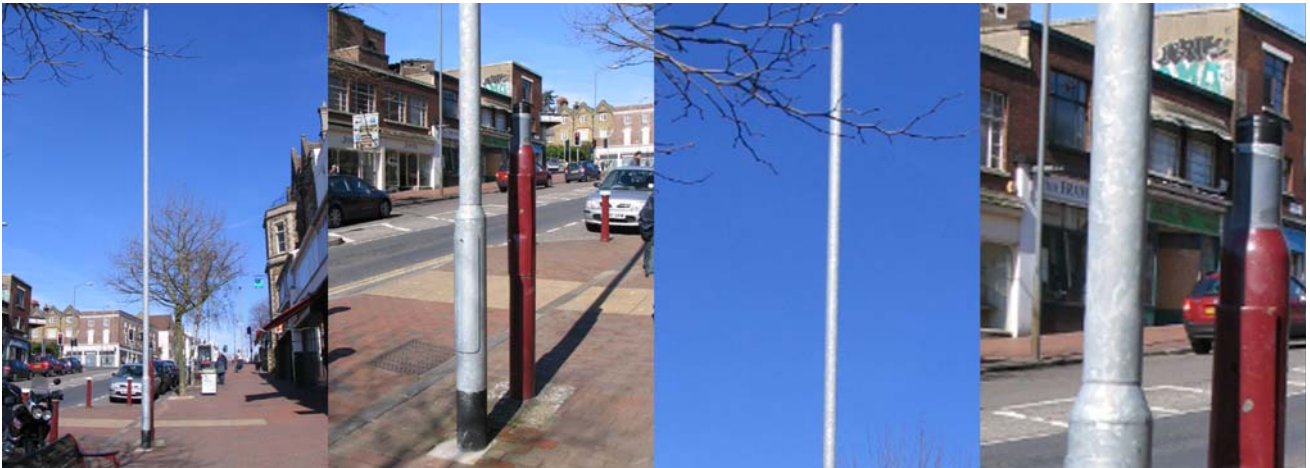
11 /
Mt. Pleasant

BASE: modern, inappropriate for area

TOP: bracket and lamp missing

- 1) installation left unfinished for months
- 2) column set into concrete instead of cobble stones (see adjacent left over)
- 3) base of previous column left without a purpose

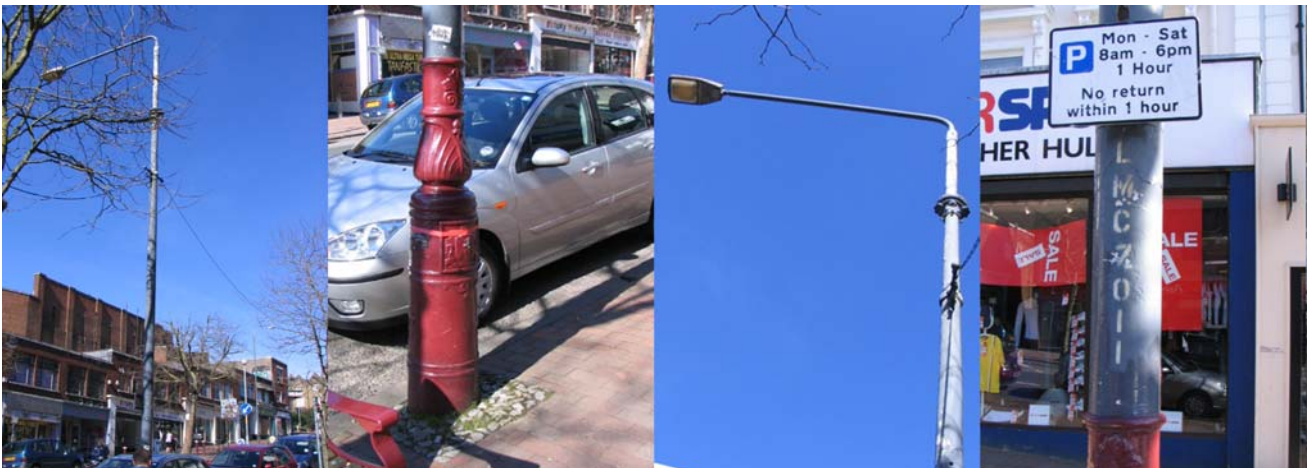
12 / LMCZ011
Mt. Pleasant

BASE: original, column original up to bracket

TOP: modern, inappropriate bracket for area

- 1) paint flaking on top of column
- 2) electricity access door strapped

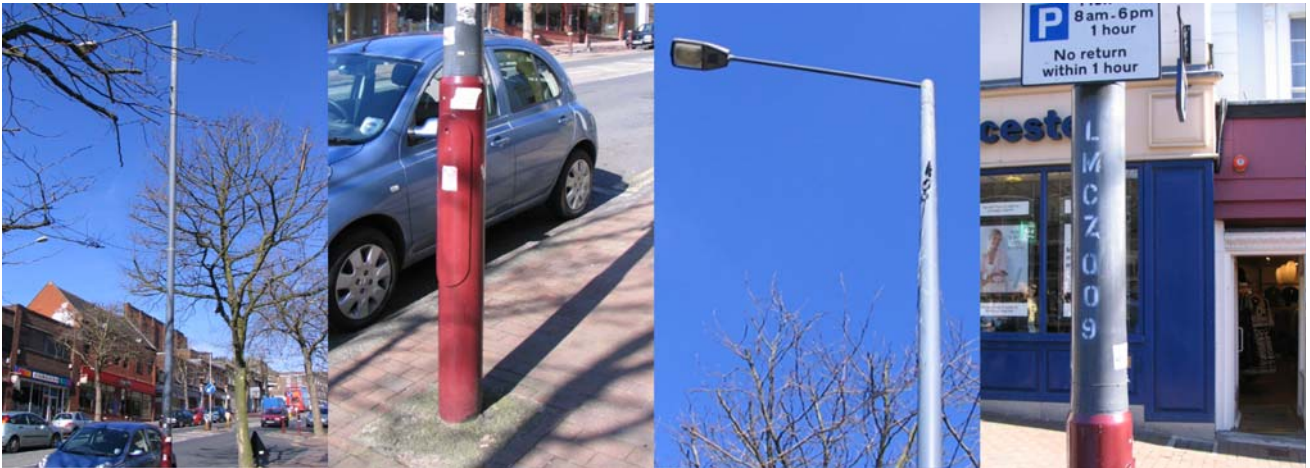
13 / LMCZ009
Mt. Pleasant

BASE: modern, inappropriate for area

TOP: modern, inappropriate for area

1) column set into concrete instead of cobble stones

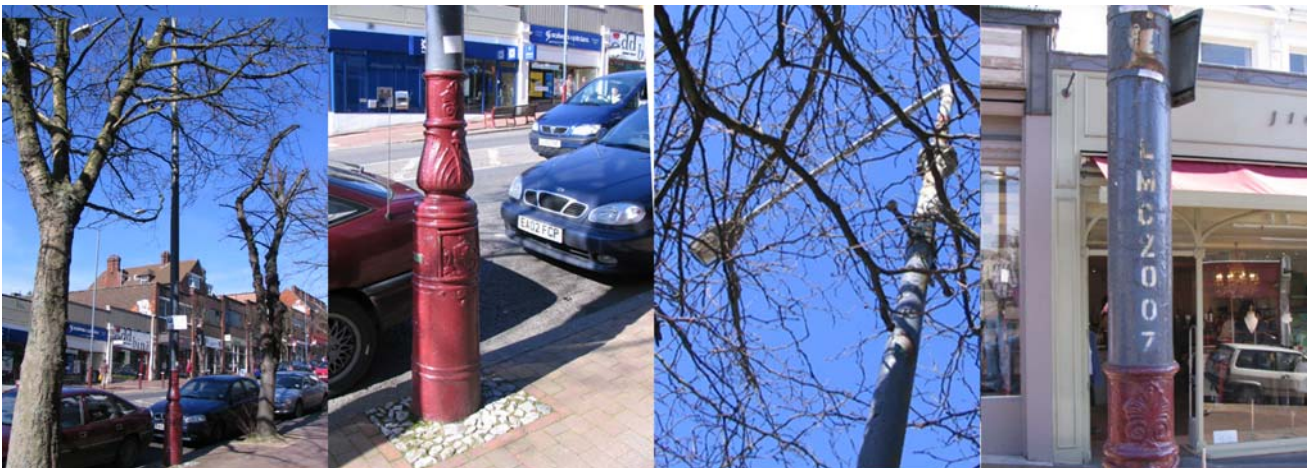
14 / LMCZ007
Mt. Pleasant

BASE: original, column original up to bracket

TOP: modern, inappropriate bracket for area

1) paint flaking on top of column
2) some corrosion on top of column

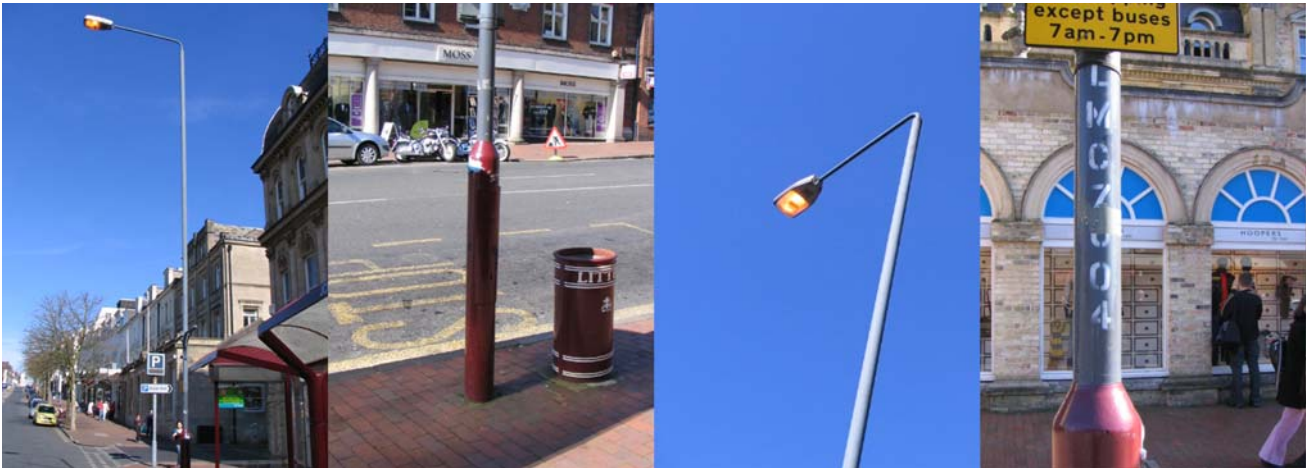
15 / LMCZ004
Mt. Pleasant

BASE: modern, inappropriate for area

TOP: modern, inappropriate for area

1) light on during day

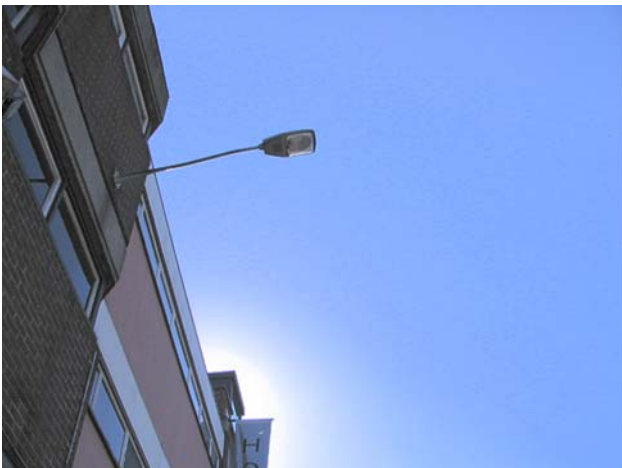
16 / (Hoopers)
Mt. Pleasant

BASE: none, fixed on building

TOP: modern, inappropriate for area

1) identification impossible

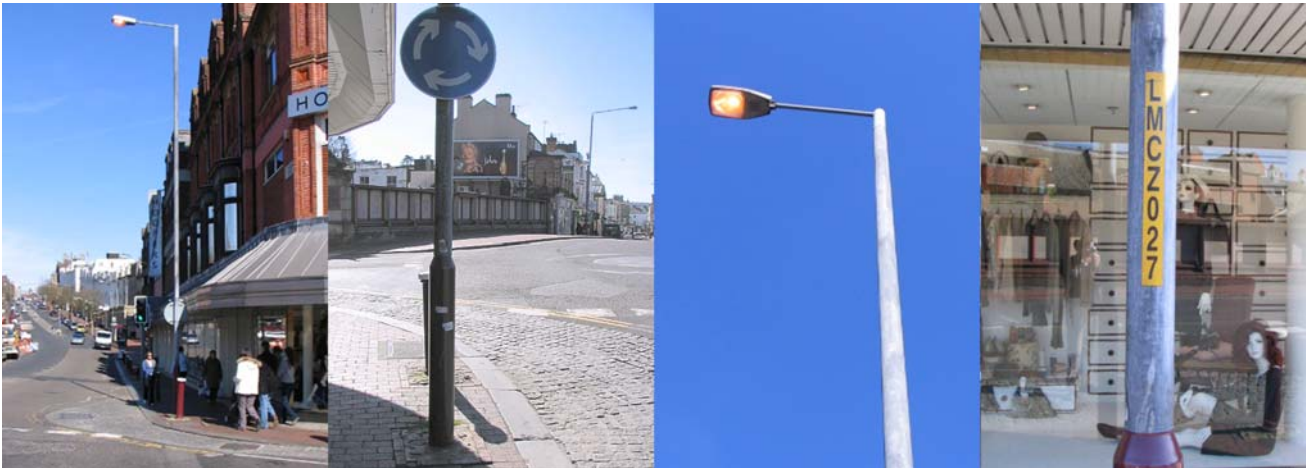
17 / LMCZ027
Mt. Pleasant

BASE: modern, inappropriate for area

TOP: modern, inappropriate for area, short bracket

- 1) Light on during day
- 2) yellow identification sticker

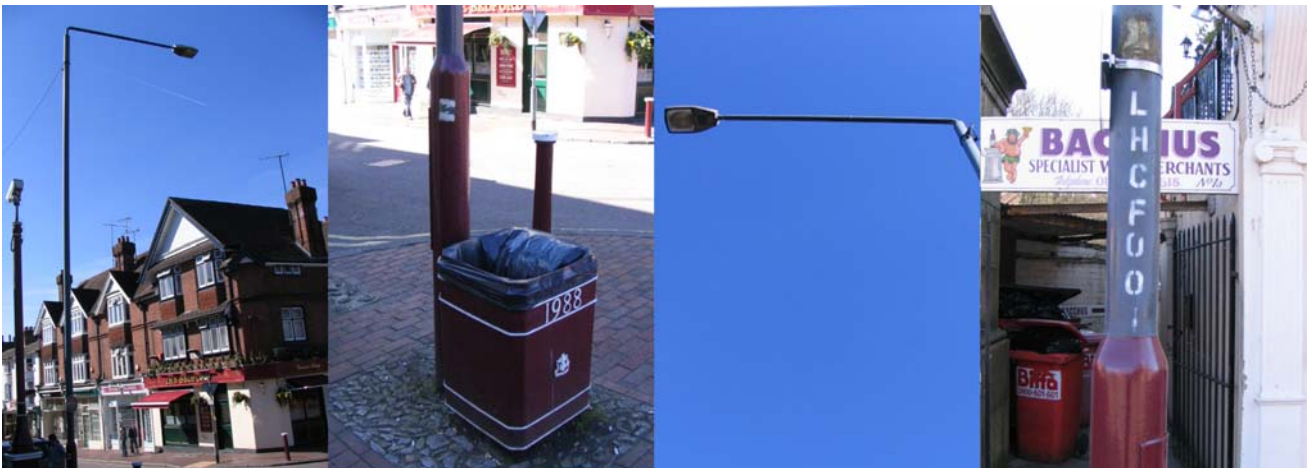
18 / LHCF001
Mt. Pleasant / High Street

BASE: modern, inappropriate for area

TOP: modern, inappropriate for area

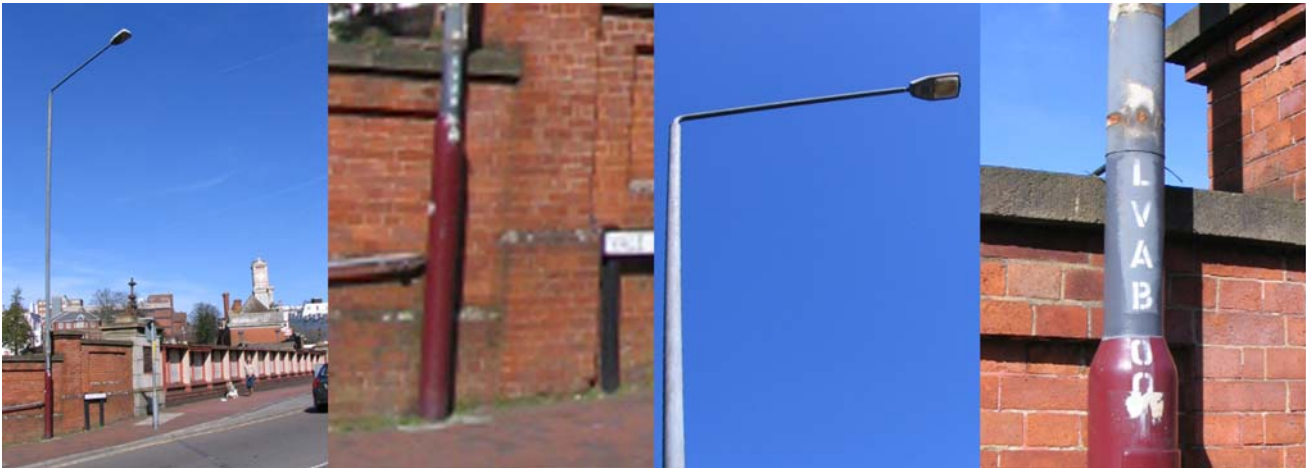
19 / LVAB00?

BASE: modern, inappropriate for area

TOP: modern, inappropriate for area

1) identification partially missing

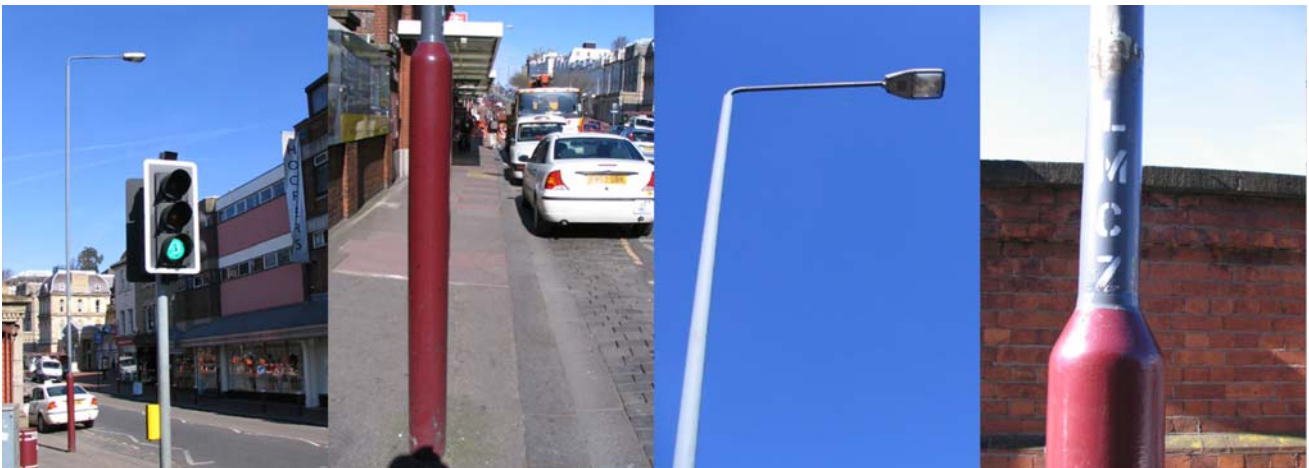
20 / LMCZ???

BASE: modern, inappropriate for area

TOP: modern, inappropriate for area

1) identification partially overpainted

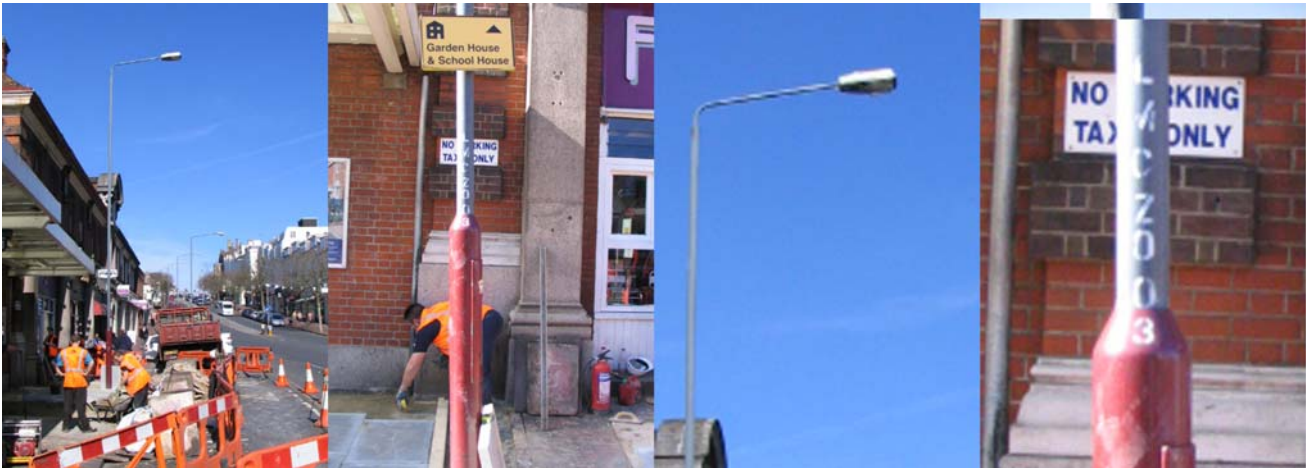
21 / LMCZ003
Mt. Pleasant / Station

BASE: modern, inappropriate for area

TOP: modern, inappropriate for area

REMARKS:
1) fly posting

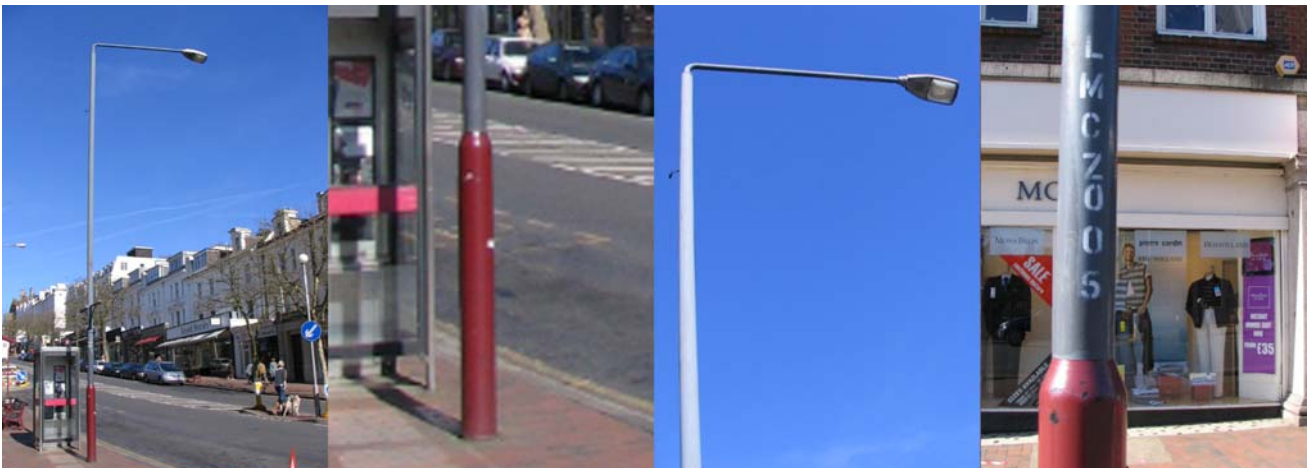
22 / LMCZ005
Mt. Pleasant

BASE: modern, inappropriate for area

TOP: modern, inappropriate for area

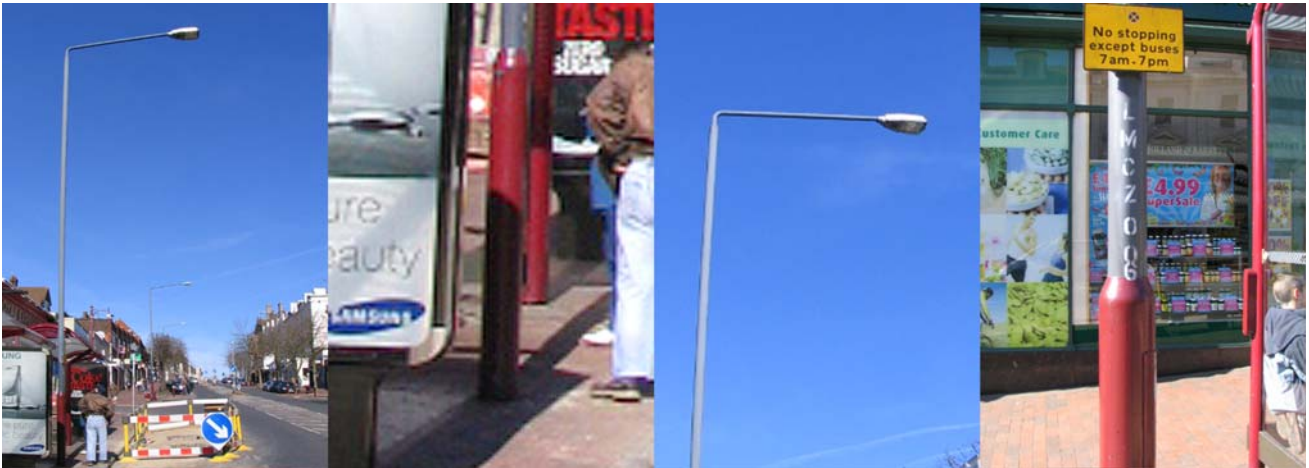
23 / LMCZ006
Mt. Pleasant

BASE: modern, inappropriate for area

TOP: modern, inappropriate for area

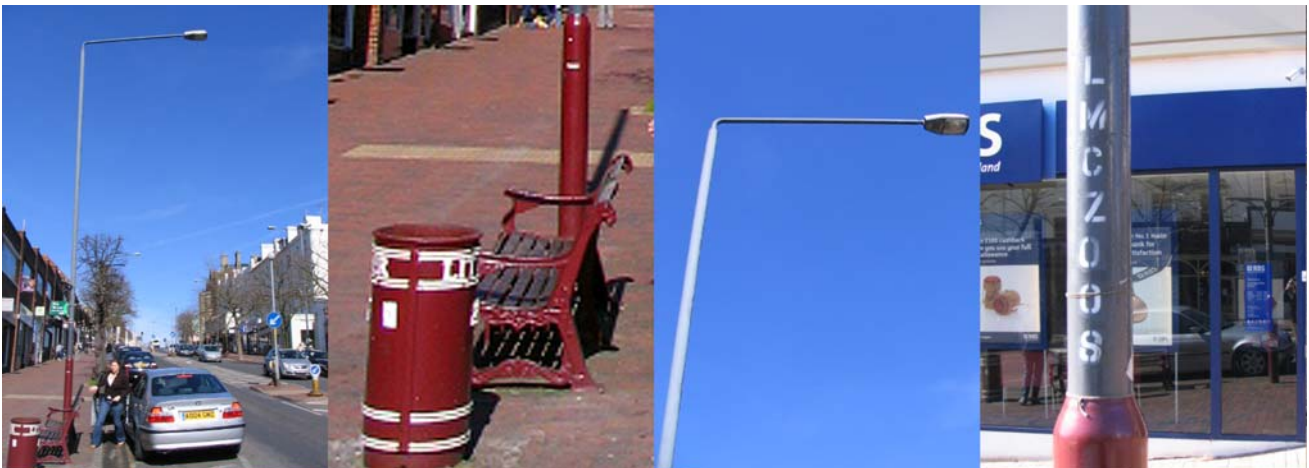
24 / LMCZ008
Mt. Pleasant

BASE: modern, inappropriate for area

TOP: modern, inappropriate for area

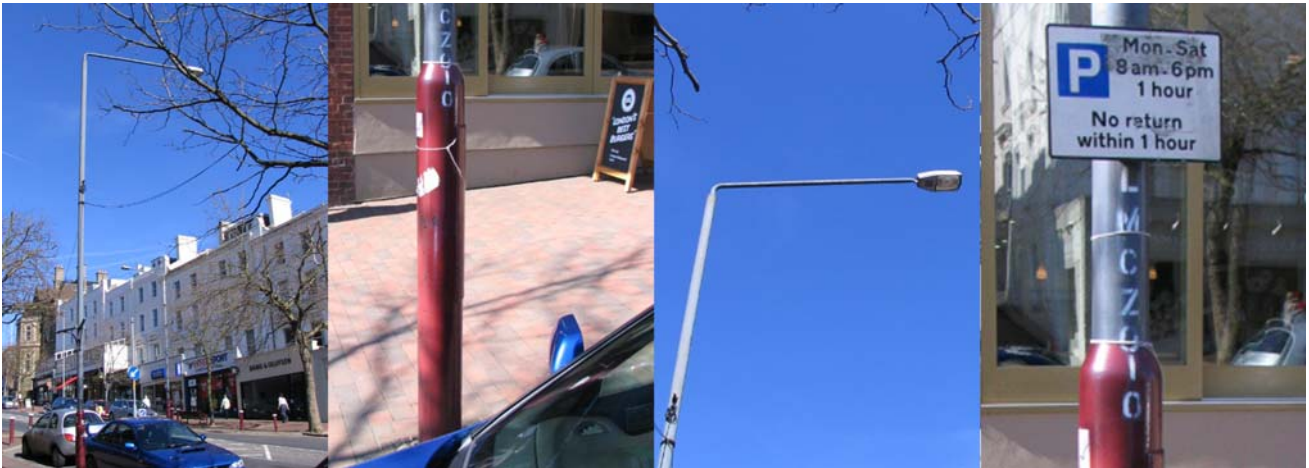
25 / LMCZ010
Mt. Pleasant

BASE: modern, inappropriate for area

TOP: modern, inappropriate for area

1) correction needed on GIS map

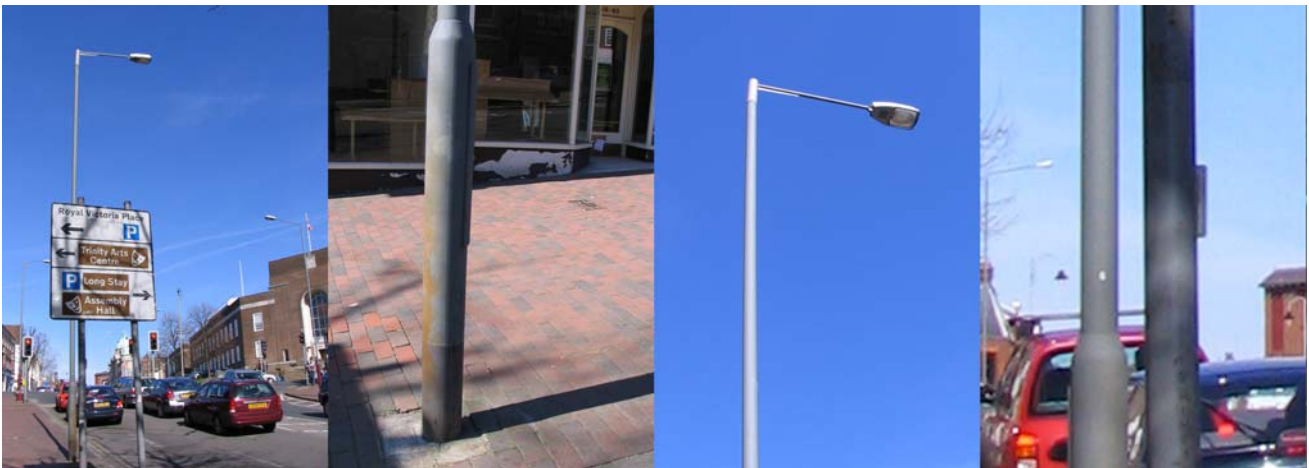
26 /
Mt. Pleasant

BASE: modern, inappropriate for area

TOP: modern, inappropriate for area

- 1) no identification
- 2) not painted, first signs of corrosion
- 3) column set into concrete instead of cobble stones
- 4) correction needed on GIS map

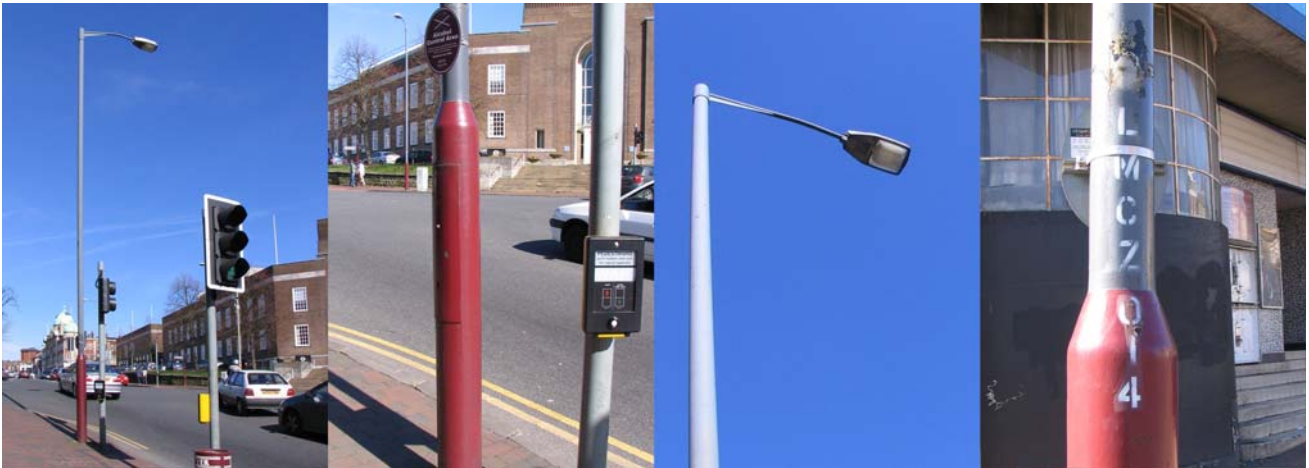
27 / LMCZ014
Mt. Pleasant

BASE: modern, inappropriate for area

TOP: modern, inappropriate for area, cast, short bracket

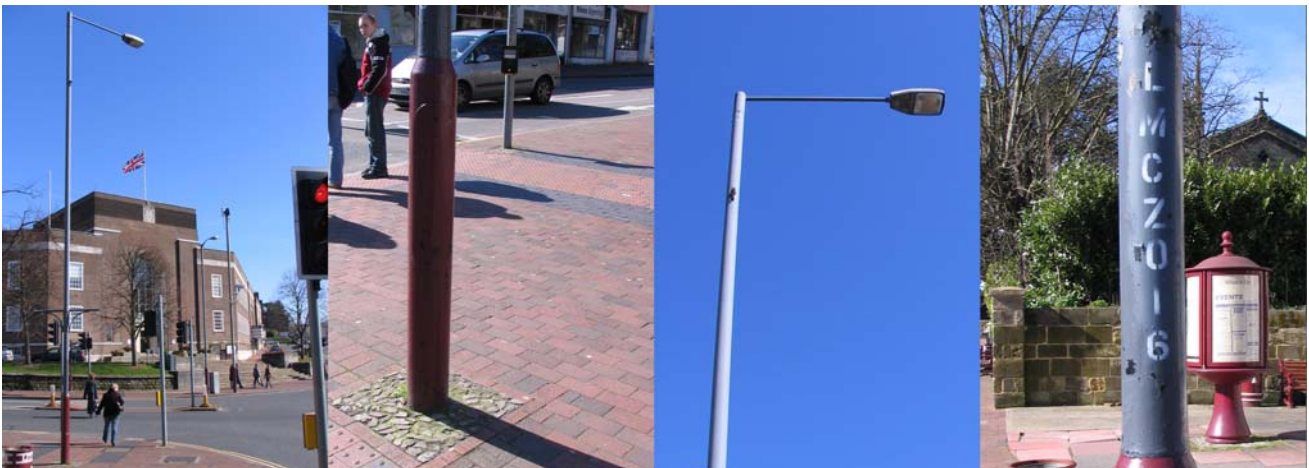
28 / LMCZ016
Mt. Pleasant / Church Road

BASE: modern, inappropriate for area

TOP: modern, inappropriate for area

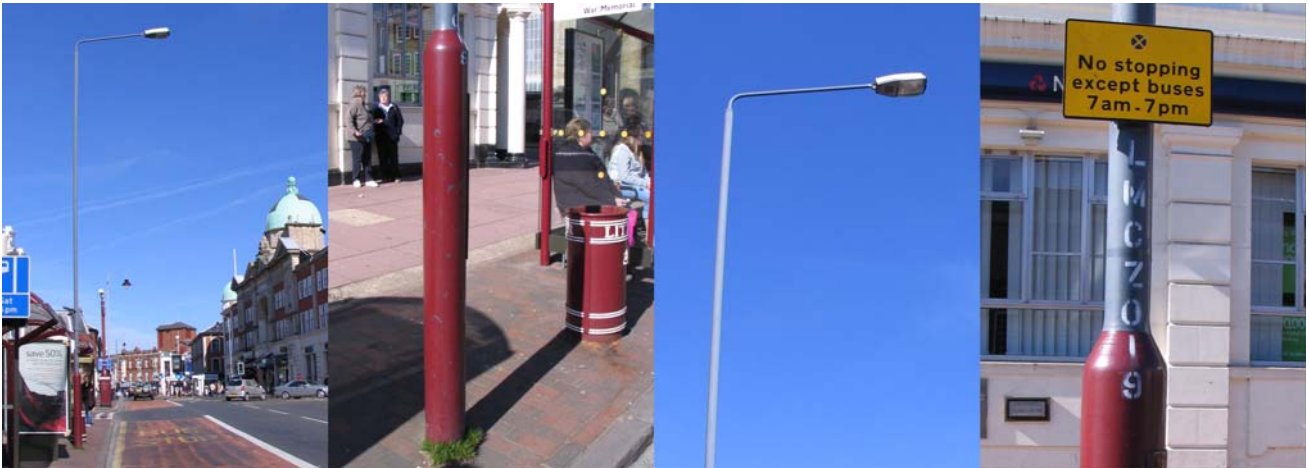
29 / LMCZ019
Mt. Pleasant

BASE: modern, inappropriate for area

TOP: modern, inappropriate for area

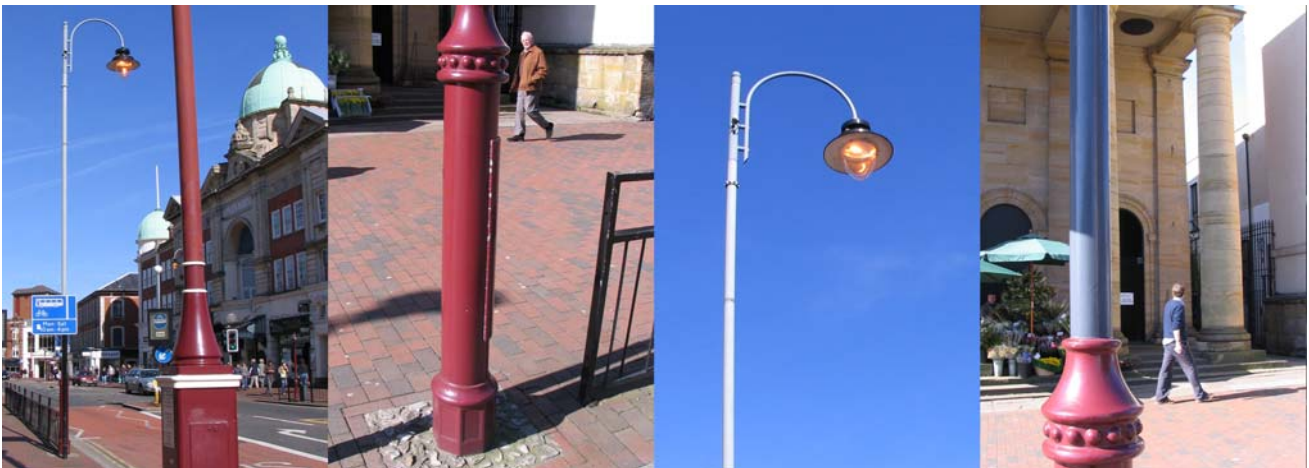
30 /
Mt. Pleasant

- 1) identification overpainted
- 2) light on during day

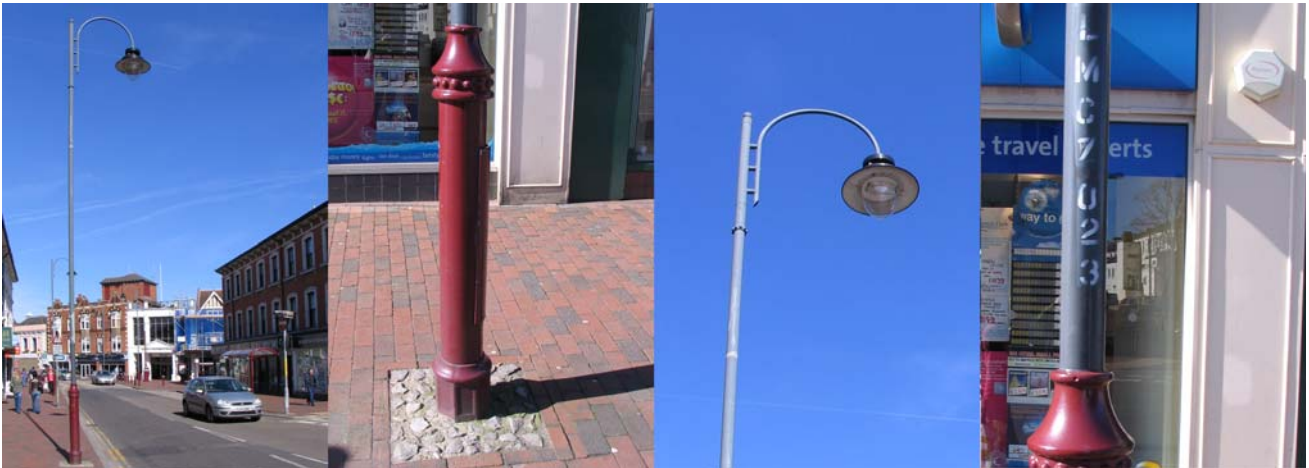
31 / LMCZ023
Mt. Pleasant

STYLE: Replica

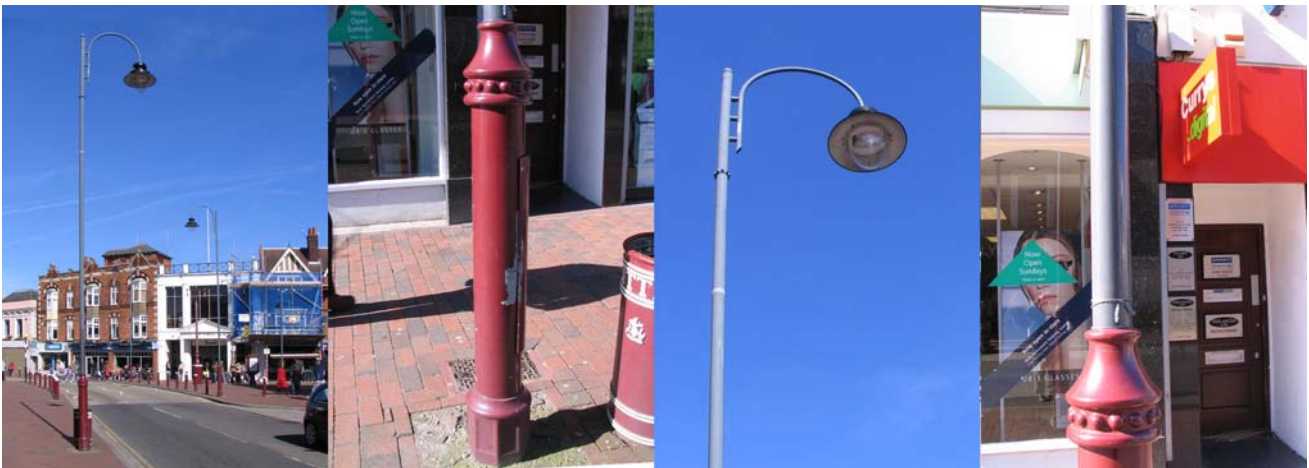
32 /
Mt. Pleasant

1) identification overpainted
