Kent's Highways service

to create awareness and gain support for improvement
and better maintenance services for pavements,
lampposts and signage in Royal Tunbridge Wells

Case 2 - Mount Pleasant and Crescent Road - Streetlights

Date of survey:
13 March 2007

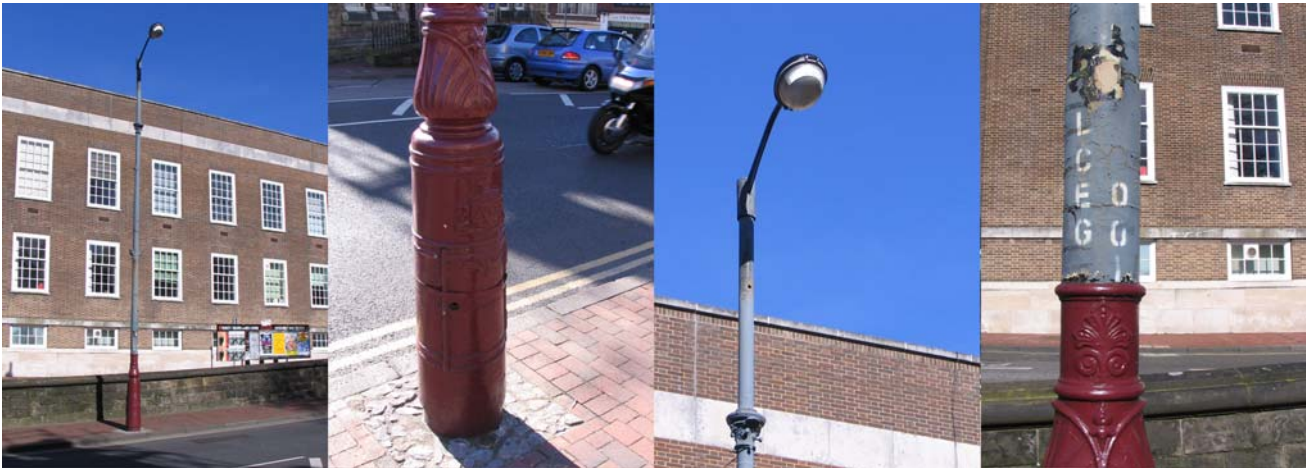
33 / LCEG001
Crescent Road

BASE: original, column original up to bracket

TOP: modern, inappropriate for area, cast, short bracket, different lamp

- 1) paint flaking on top of column
- 2) corrosion
- 3) electricity access door strapped

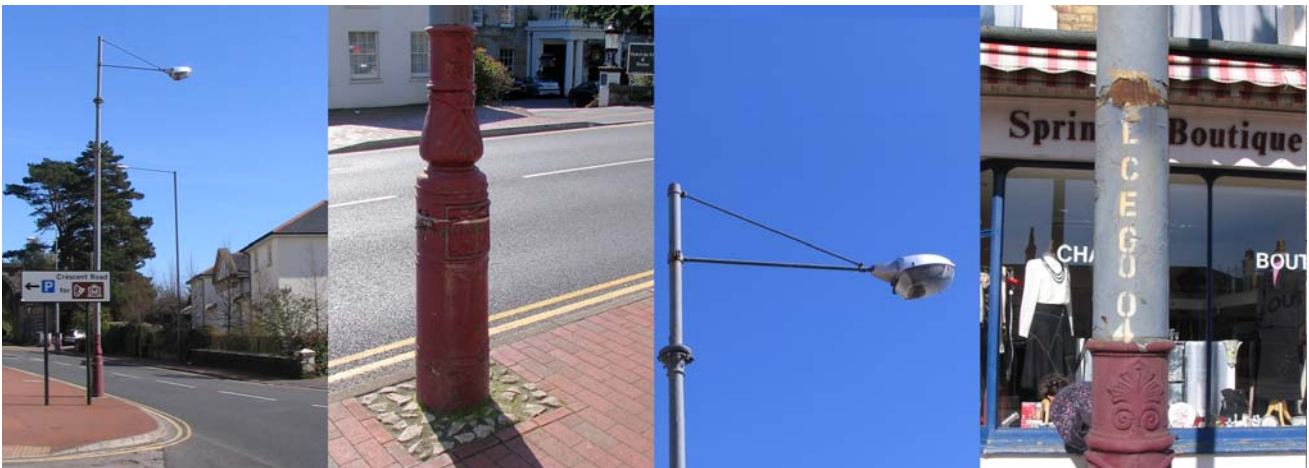
34 / LCEG004
Crescent Road

BASE: original, column original up to bracket

TOP: modern bracket, different lamp

- 1) paint flaking on top of column
- 2) corrosion
- 3) electricity access door strapped

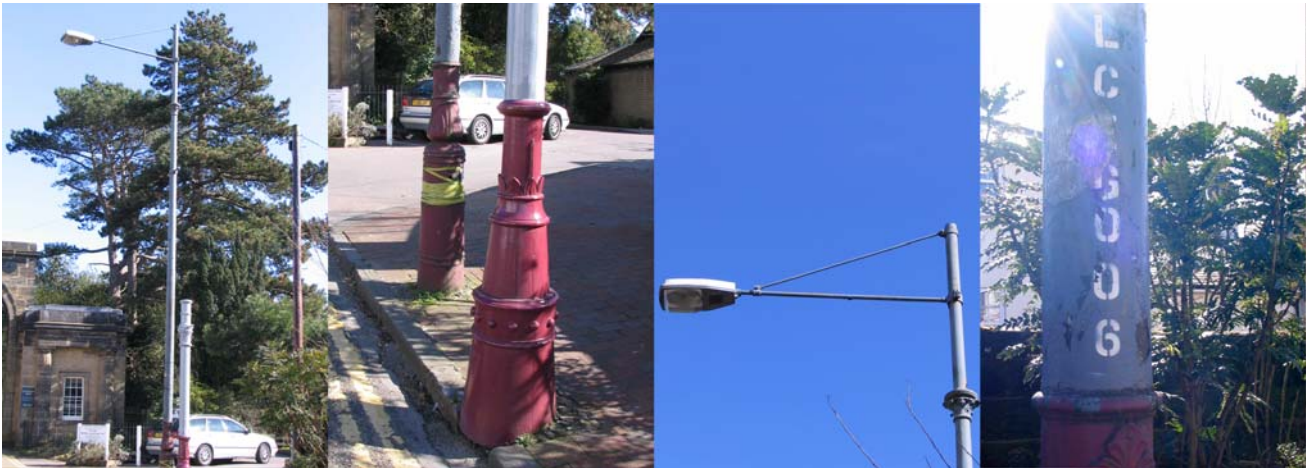
35 / LCEG006
Crescent Road

BASE: original, column original up to bracket

TOP: modern bracket

- 1) paint flaking on column, top and base
- 2) electricity access door missing, live wire covered with corrugated paper
- 3) correction needed on GIS map

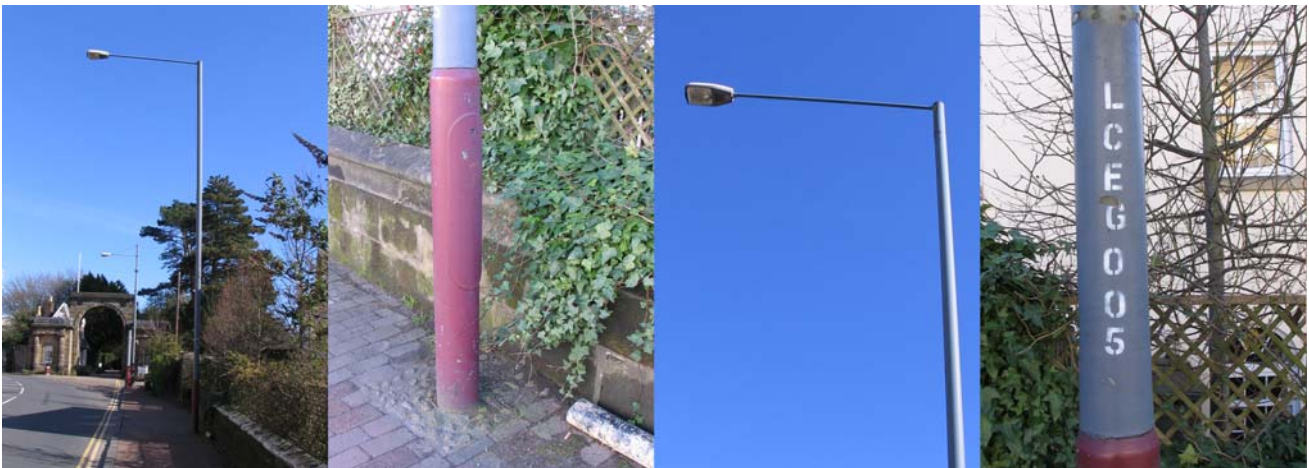
36 / LCEG005
Crescent Road

BASE: modern, inappropriate for area

TOP: modern, inappropriate for area

- 1) correction needed on GIS map

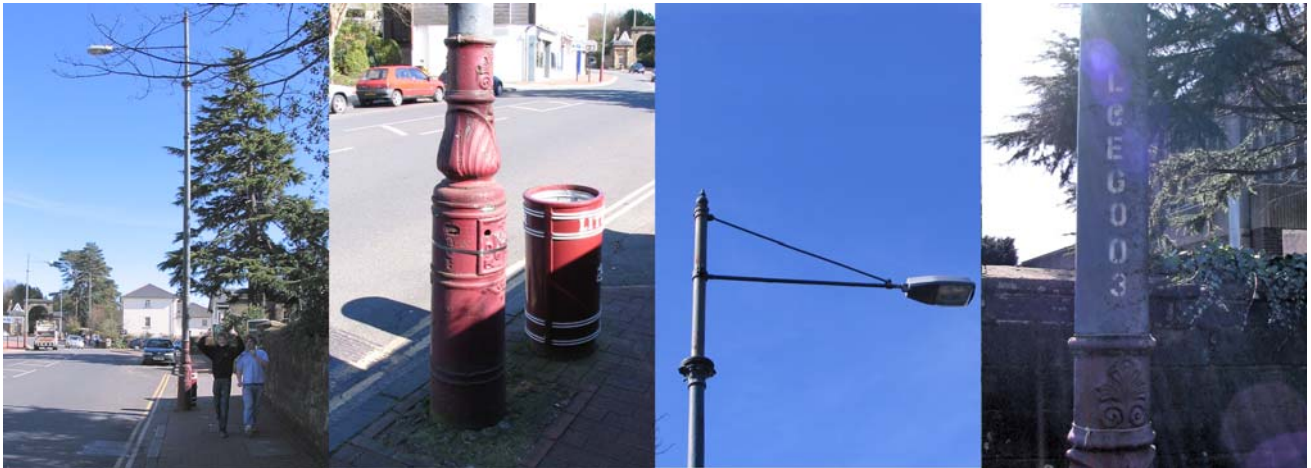
37 / LCEG003
Crescent Road

BASE: original, column original to top

TOP: modern bracket

1) paint flaking on column, top and base

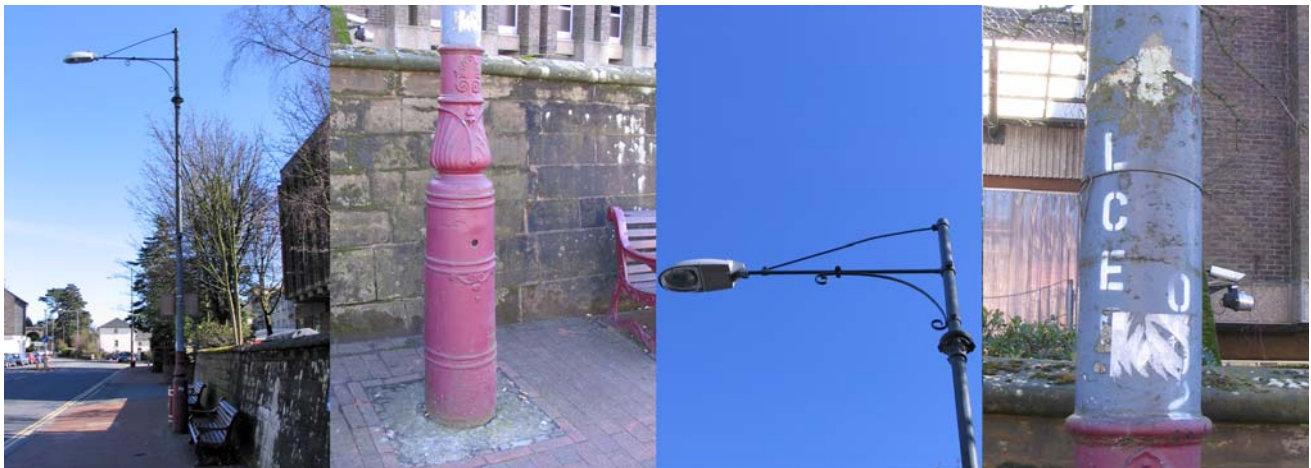
38 / LCE?002
Crescent Road

BASE: original, column original up to bracket

TOP: modern bracket
